Technical Enforcement Support at Hazardous Waste Sites Zone III Regions 5,6, and 7

# PRELIMINARY ASSESSMENT/ VISUAL SITE INSPECTION

BASF CORPORATION TROY FACILITY TROY, MICHIGAN 48084 MID 057 007 478

FINAL REPORT

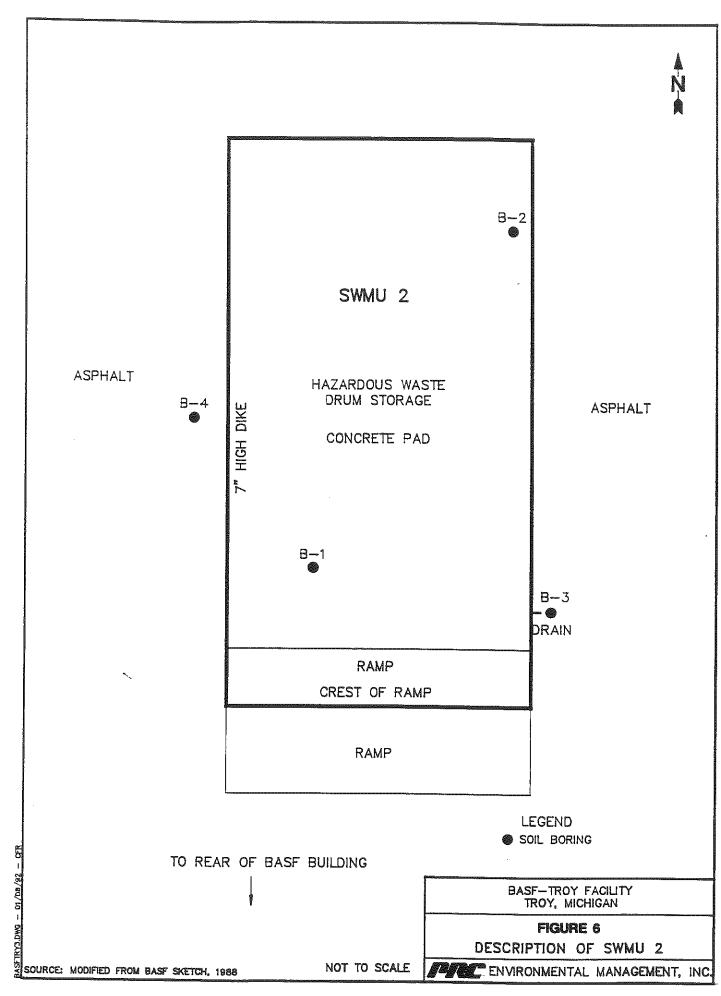
The hazardous waste drum storage area was located in an asphalt-paved area north of Building I, the main building. The unit consisted of a 6-inch concrete pad measuring 33 feet by 15 feet. The pad had a 7-inch berm around its boundaries. The pad also had a drain that led to the asphalt surface and was controlled by a manual valve. Figure 6 shows the layout of this unit and the locations of samples collected during closure. Photographs

The unit consisted of a concrete pad and was surrounded by a 7-inch dike to contain spills. A 2-inch-diameter pipe and valve also were installed to drain accumulated rain water from the diked area. When the diked area was full of rain water, the water was discharged directly to the pavement and subsequently to the combined sewer system. Facility representatives indicated that the accumulated rain water was inspected visually before discharge to ensure that stored drums had not leaked (Hoermann, 1992).

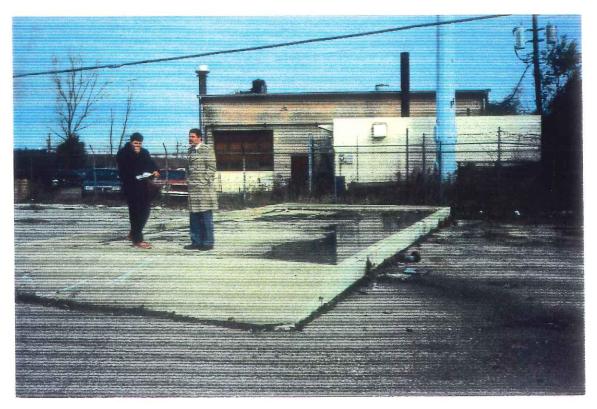
1 North

The pad was empty and appeared to be clean. The valve to the drain was dismantled. No evidence of drum storage or releases from the pad was observed.

Hazardous Waste Drum Storage Pad

Location: SWMU 1 11/5/91 Date:

No further action is recommended at this time.
